**LAKE SUPERIOR**

**STATE UNIVERSITY**

**Five-Year Capital Outlay Master Plan**

**Facility Assessment Report**

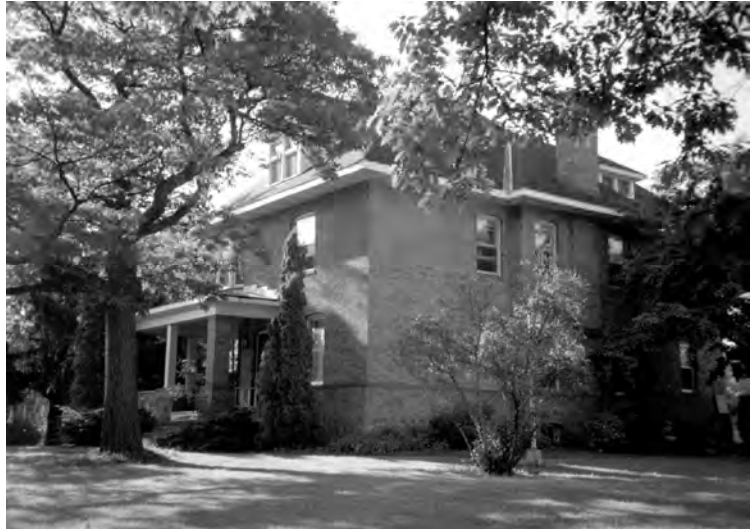
**Facility Condition Index:** 51% (Poor)

Building infrastructure is in fair condition with no major problems. However, this facility is circa 1920 and needs extensive work to be brought into the 21st century.

Year	Description	Estimate
2012 - 13	Replace roof	\$36,000
2012 - 13	Clean/abate lead & asbestos in basement	\$7,000
2012 - 13	Install ADA door hardware	\$5,000
2012 - 13	Replace windows	\$50,000
2013 - 14	Replace electrical panels	\$7,000
2013 - 14	Replace carpeting	\$15,000
2013 - 14	Repair/replace interior ceilings	\$8,000
2014 - 15	Renovate both entrances	\$30,000
2014 - 15	New fire alarm system	\$25,000
2014 - 15	Renovate sanitary system	\$20,000
2014 - 15	Clean, tuck-point and seal coat exterior	\$45,000
2014 - 15	Install new HVAC system with steam to HW heating conversion	\$200,000
2014 - 15	Install ADA access ramp	\$36,000
	<b>TOTAL</b>	<b>\$484,000</b>

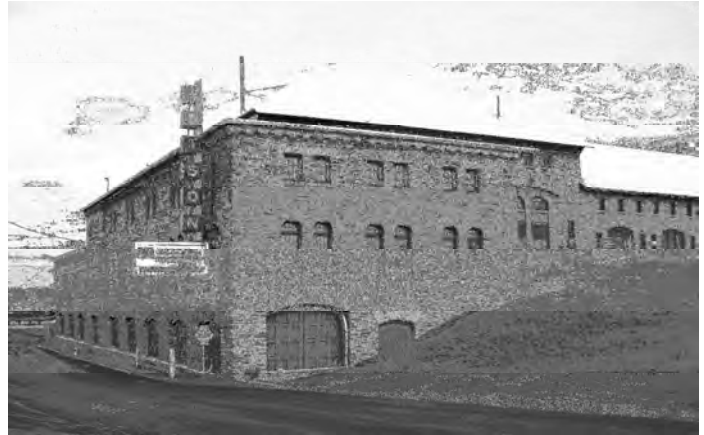
**Mandated Facility Standards:** N/A  
**Replacement Value:** (2010 valuation) \$313,100  
**Facility Condition Index:** +100% (Poor)

**Utility System Infrastructure:** The entire building interior needs to be remodeled. The mechanical and electrical systems are old and inefficient. The space configuration does not meet the current needs. The building does not meet ADA standards for plumbing or multi-floor access. The building is listed with the National Historic Civil Engineering Landmarks.

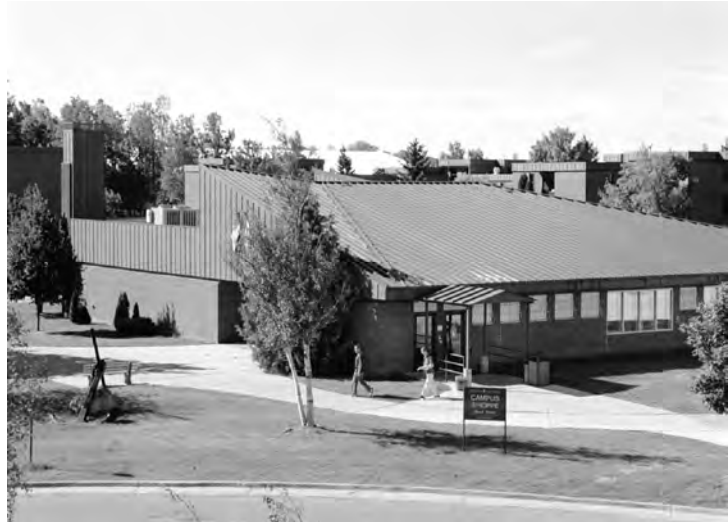
**Facility Condition Index:** 5% (Fair)

Building infrastructure is in fair condition with no major problems.

Year	Description	Estimate
2012 - 13	Replace fascia & soffit	\$15,000
2012 - 13	Dewater basement	\$5,000
2013 - 14	Install new fire alarm system	\$31,000
2014 - 15	Replace windows throughout building	\$40,000
2014 - 15	New electrical feed and panel	\$40,000
	TOTAL	<u>\$131,000</u>

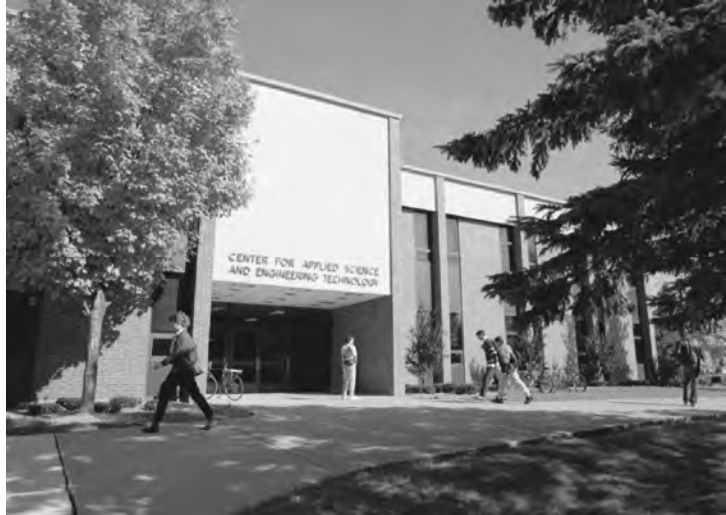
**Facility Condition Index:** 4% (Good)

Building is in generally good condition.

Year	Description	Estimate
2010 - 11	Install emergency generator for computer room	\$30,000
2011 - 12	Replace and renovate cooling system	\$250,000
2012 - 13	Replace carpeting and flooring	\$30,000
2012 - 13	Repair brick and & drip edge east side	\$5,000
2013 - 14	Install overhead door in welding area	\$54,000
2013 - 14	Replace classroom furnishings	\$54,000
2014 - 15	Replace 13 exterior doors	\$40,000
2014 - 15	Overhead lift for foundry/crane machine shop	\$30,000
2014 - 15	HVAC renovation and controls	\$80,000
2014 - 15	Re-core and change all locking hardware to ADA	\$48,000
2014 - 15	Restroom piping retrofit for ADA compliance	\$12,000
	<b>TOTAL</b>	<b>\$633,000</b>

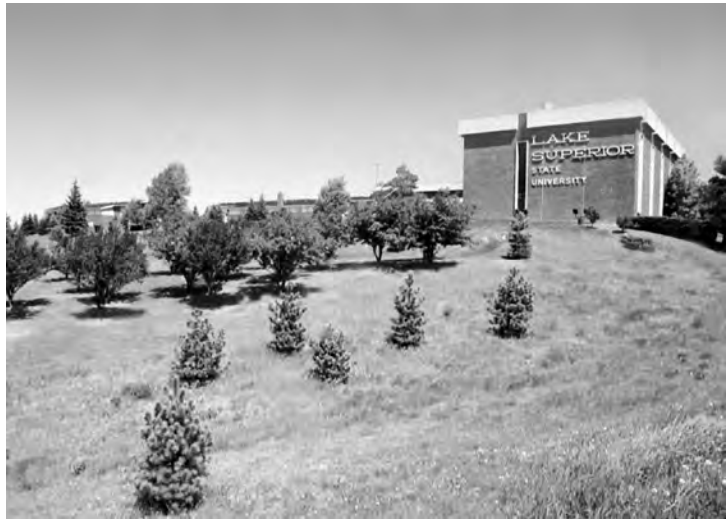
**Facility Condition Index:** 5% (Fair)

The building and boiler systems are in good condition.

Year	Description	Estimate
2010 - 11	Replace condensate pump	\$7,500
2012 - 13	Complete steam tunnel repairs	\$50,000
2013 - 14	Replace underground storage tanks	\$100,000
2014 - 15	Replace stone fascia	\$25,000
	TOTAL	\$182,500

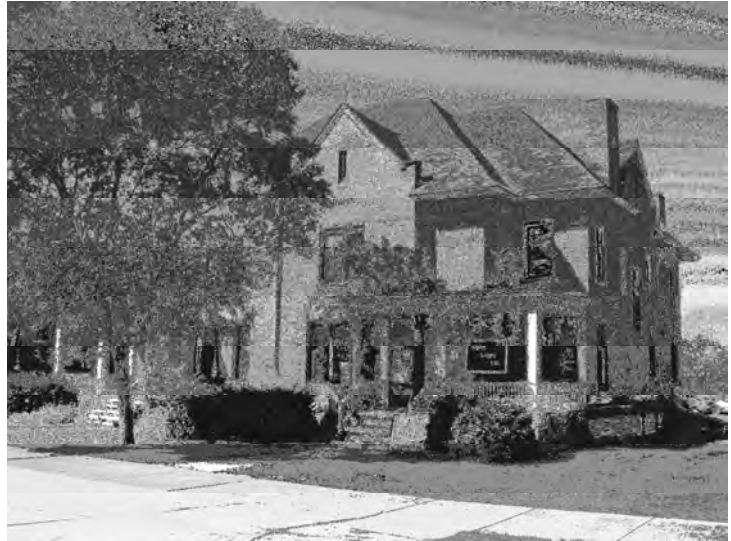
**Facility Condition Index:** 14% (Poor)

Building infrastructure is in fair condition with no major problems.

Year	Description	Estimate
2012 - 13	Clean, tuck-point and seal exterior	\$45,000
2012 - 13	Replace basement windows	\$6,000
2012 - 13	Clean/abate basements	\$9,000
2012 - 13	Re-core all locking hardware	\$5,000
2013 - 14	Repair fascia and soffit	\$10,000
2013 - 14	Repair both main entrances	\$24,000
2013 - 14	Install 2 new boilers	\$18,000
2013 - 14	Replace carpet	\$10,000
2014 - 15	Replace interior & exterior cellar doors	\$7,000
2014 - 15	Install card access entry system	\$10,000
2014 - 15	Add fire suppression system	\$45,000
2014 - 15	Install ADA accessibility ramp	\$35,000
	TOTAL	\$224,000

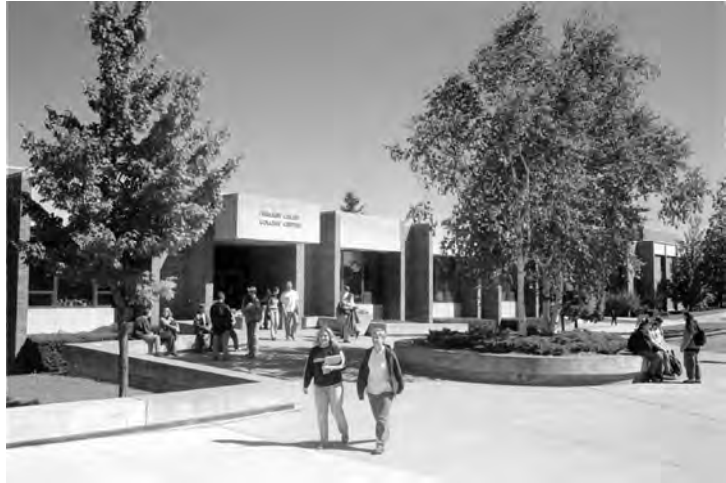
**Facility Condition Index:** 7% (Fair)

The building infrastructure is in generally good condition with only some specific issues to be addressed in the Five-Year Capital Plan.

Year	Description	Estimate
2010 - 11	Remodel food service offices	\$20,000
2010 - 11	Repaint upstairs hallway	\$6,500
2011 - 12	Phase II remodeling	\$50,000
2011 - 12	Modify fire alarm system	\$15,000
2012 - 13	Replace electrical panels	\$7,000
2012 - 13	Landscape Improvements	\$30,000
2013 - 14	Refinish ballroom floor	\$10,000
2013 - 14	Add more electrical power to Room 201 and galley	\$10,000
2013 - 14	Replace single pane windows	\$90,000
2013 - 14	Phase III remodeling	\$30,000
2013 - 14	Replace EPDM roofing system	\$120,000
2013 - 14	Remodel guest rooms	\$25,000
2014 - 15	Install washing machine and dryer	\$5,000
2014 - 15	Replace staging	\$10,000
2014 - 15	Install emergency lighting system	\$30,000
2014 - 15	Emergency generator system	\$300,000
2014 - 15	Phase IV remodel	\$30,000
2014 - 15	New cooling coil for HVAC west end	\$35,000
2014 - 15	New dish machine galley and servery	\$50,000
2014 - 15	Upgrade elevator controls to meet ADA	\$10,000

2014 - 15	Re-core and replace all locking hardware for ADA	\$30,000
	TOTAL	\$913,500

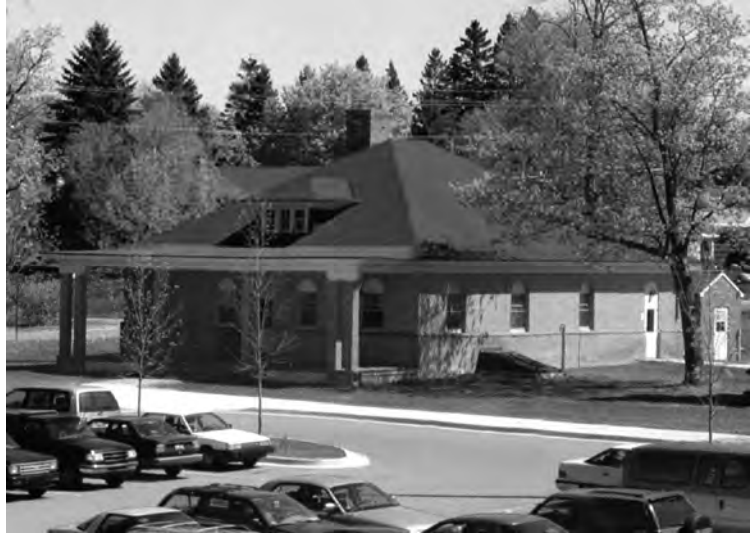
**Facility Condition Index:** Poor — Building Closed

In August of 2005, East Hall was vacated.

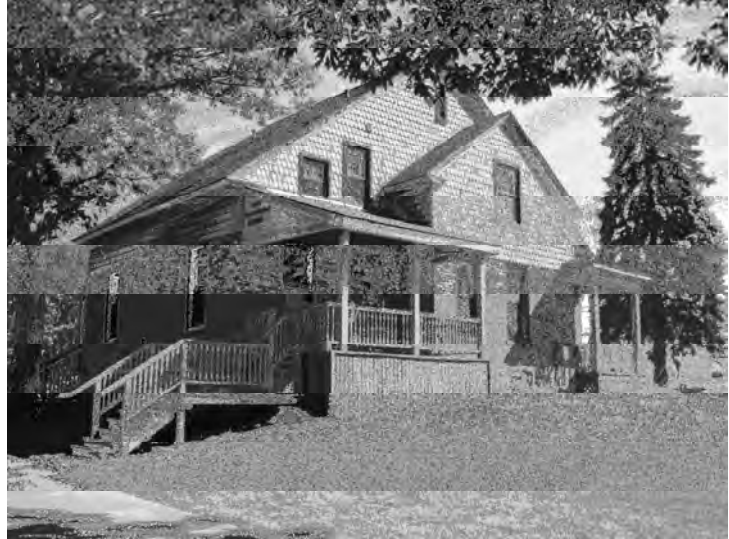
**Facility Condition Index:** 74% (Poor)

Building infrastructure is in poor condition, as the building interior needs to be remodeled to conform to all applicable codes.

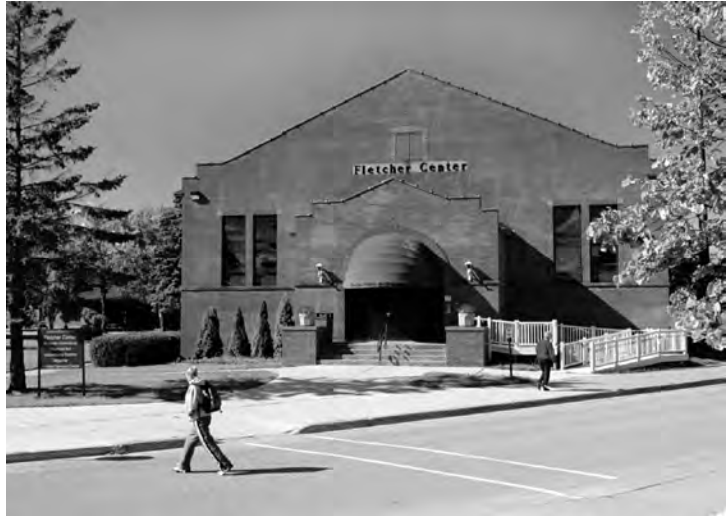
**Facility Condition Index:** 18% (Poor)

Building infrastructure is in generally fair condition. Many needs of the building are due to circa 1936 construction and the changing needs of campus.

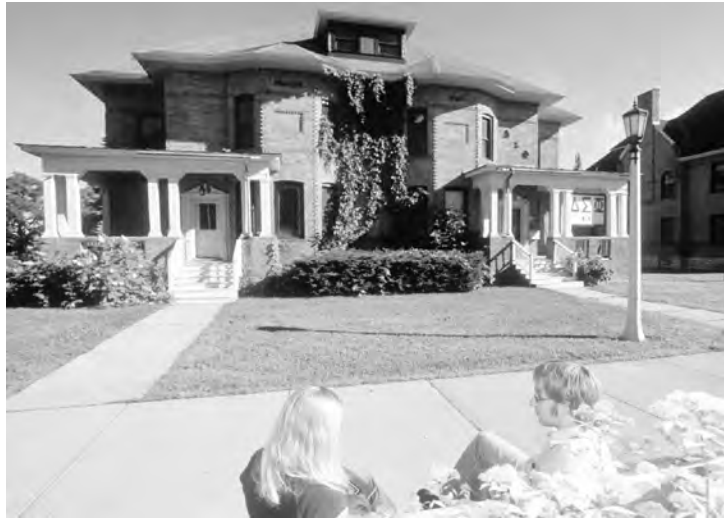
**Facility Condition Index:** 26% (Poor)

Building infrastructure is in fair condition although building interior needs to be extensively remodeled. The building is currently vacant and awaiting funding availability to conduct extensive renovations.

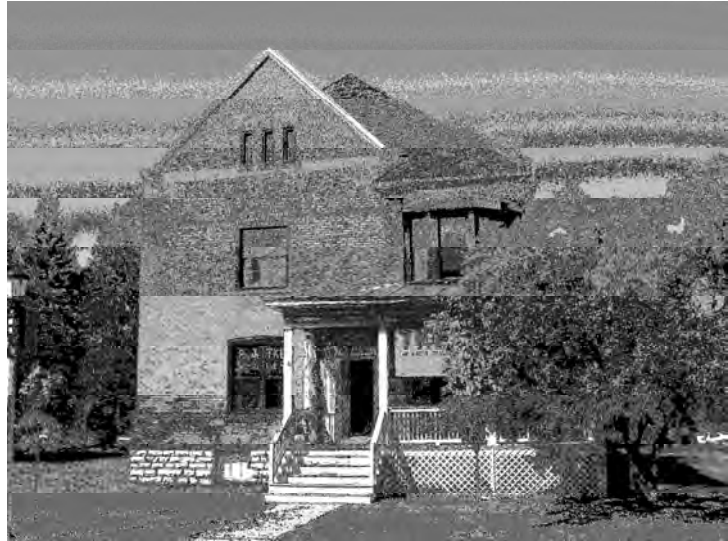
**Facility Condition Index:** 44% (Poor)

Building infrastructure is in fair condition although building interior needs extensive remodeling.

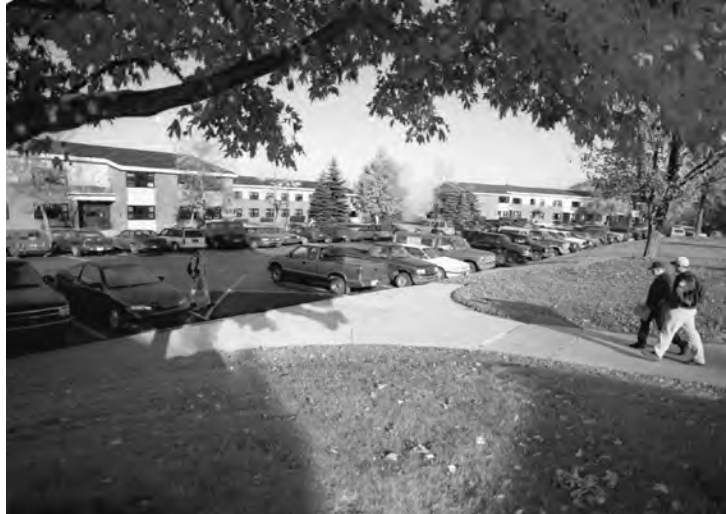
**Facility Condition Index:** 10% (Fair)

Building infrastructure is in generally fair condition although domestic water system needs replacement and the building needs to be remodeled.

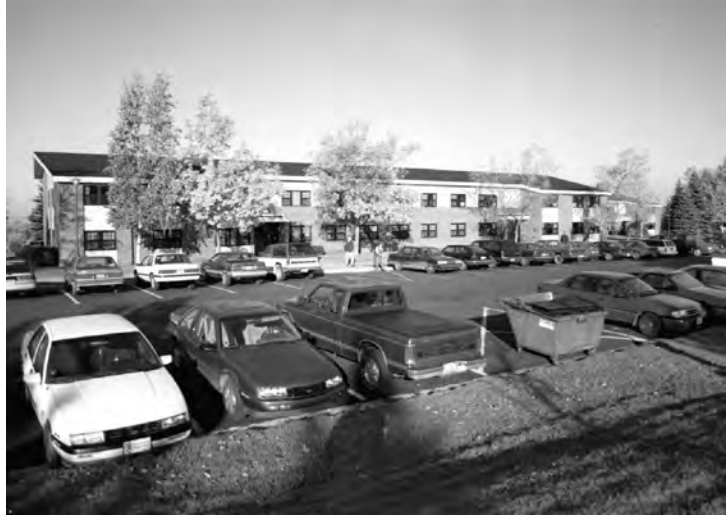
**Facility Condition Index:** 11% (Poor)

Building infrastructure is in generally fair condition although building interior needs to be remodeled.

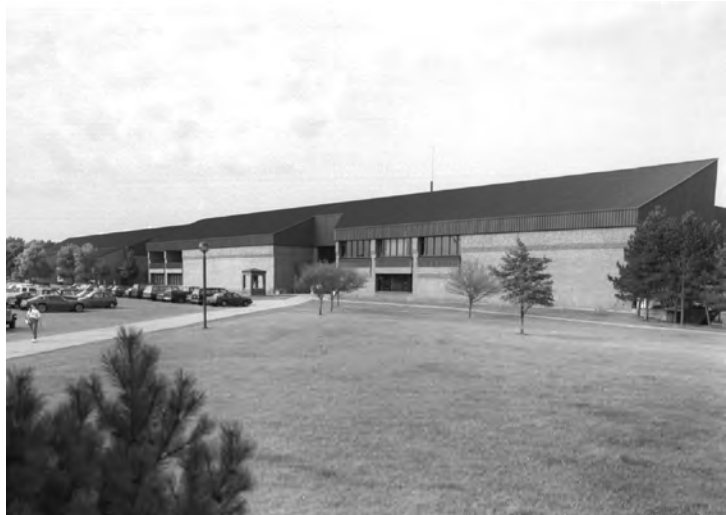
**Facility Condition Index:** 7% (Fair)

Building is in generally good condition although a new fire alarm system and a pool dehumidification system are needed.

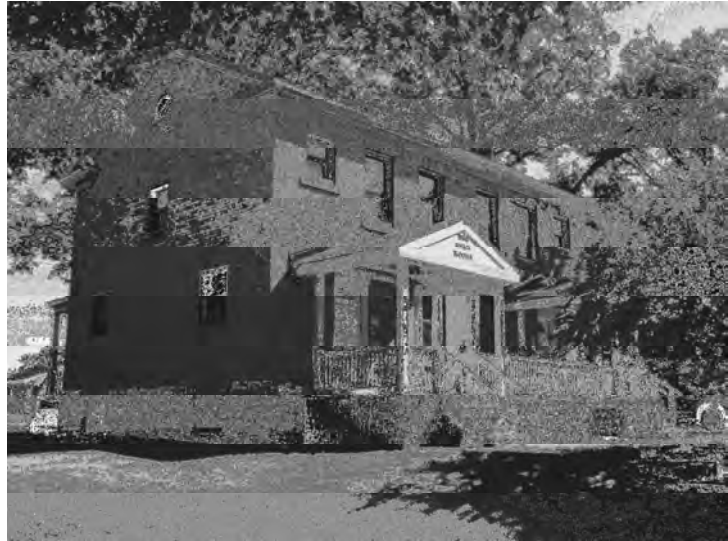
**Facility Condition Index:** 68% (Poor)

Building infrastructure is in fair condition although building interior needs to be remodeled.

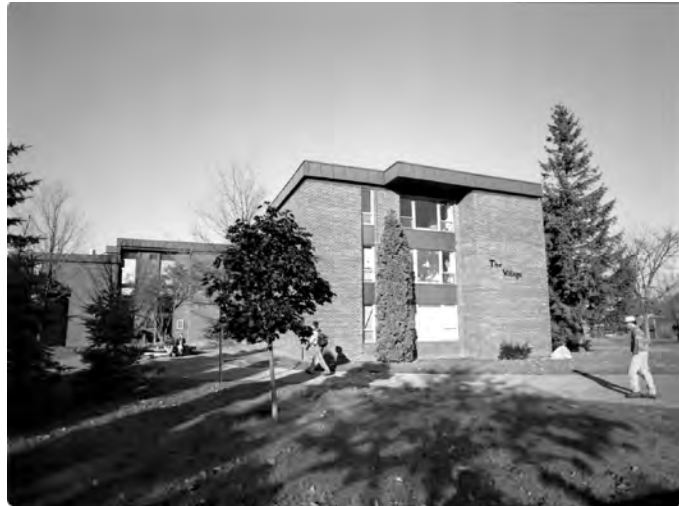
**Facility Condition Index:** 8% (Fair)

Building infrastructure is in good condition although building interiors need to be remodeled.
