Five-Year Capital Outlay Master Plan

2013

Facility Assessment Report

Lake Superior State University Five-Year Capital Outlay Master Plan and Facility Assessment Report

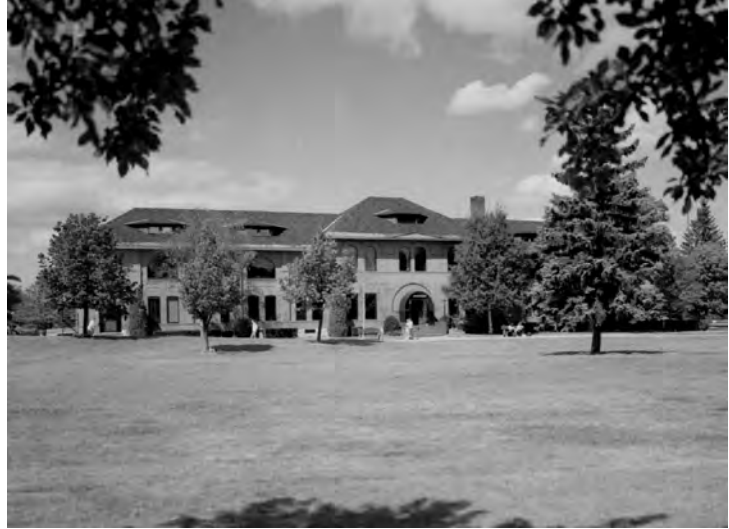
Facility Condition Index: 38% (Poor)

Utility System Infrastructure: The entire building interior needs to be remodeled. The mechanical and electrical systems are old and inefficient. The space configuration does not meet the current needs and the building does not meet ADA standards for plumbing or multi-floor access. The building is listed on the Register of National Historic Places.

Year	Description	Estimate
2012 - 13	Replace 1st floor carpet	\$7,500
2012 - 13	Repair vent stack - sewer system	\$5,000
2012 - 13	Lighting retrofit	\$20,000
2013 - 14	Rebuild dormers and new windows	\$20,000
2013 - 14	Repair floor sags	\$10,000
2013 - 14	Restore & paint exterior stairs	\$6,000
2013 - 14	Clean, tuck-point and seal coat exterior	\$45,000
2014 - 15	Metering utilities	\$22,500
2014 - 15	Dewater basement/seal basement	\$150,000
2014 - 15	Renovate men's restroom	\$15,000
2015 - 16	Renovate women's restroom	\$15,000
2015 - 16	New fire alarm system	\$36,000
2015 - 16	Replace interior doors	\$33,000
2016 - 17	Install ADA ramp & door opener system	\$40,000
2016 - 17	Renovate HVAC system & add HW heating	\$460,000
2017 - 18	Elevator	\$150,000
	TOTAL	\$1,035,000

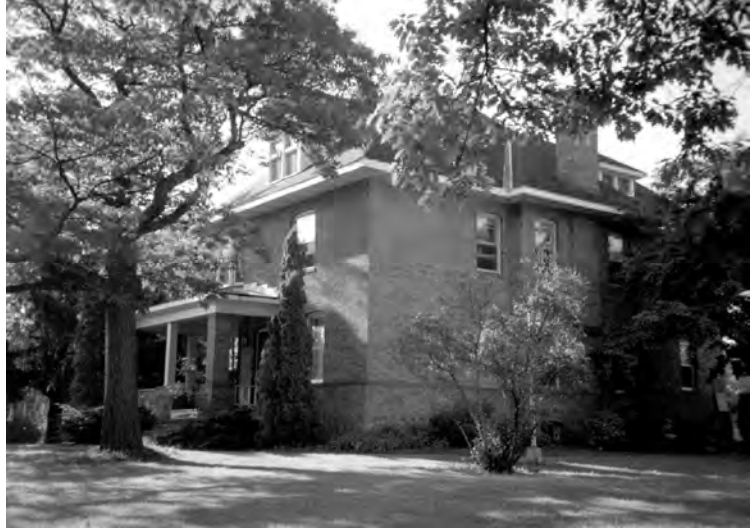
Facility Condition Index: 52% (Poor)

Building infrastructure is in fair condition with no major problems. However, this facility is circa 1920 and needs extensive work to be brought into the 21st century.

Year	Description	Estimate
2012 - 13	Replace roof	\$36,000
2013 - 14	Clean/abate lead & asbestos in basement	\$7,000
2013 - 14	Install ADA door hardware	\$5,000
2014 - 15	Replace windows	\$50,000
2014 - 15	Replace electrical panels	\$7,000
2014 - 15	Replace carpeting	\$15,000
2015 - 16	Repair/replace interior ceilings	\$8,000
2015 - 16	Renovate both entrances	\$30,000
2015 - 16	New fire alarm system	\$25,000
2016 - 17	Renovate sanitary system	\$20,000
2016 - 17	Clean, tuck-point and seal coat exterior	\$45,000
2017 - 18	Install new HVAC system with steam to HW heating conversion	\$200,000
2017 - 18	Install ADA access ramp	\$36,000
	TOTAL	<u>\$484,000</u>

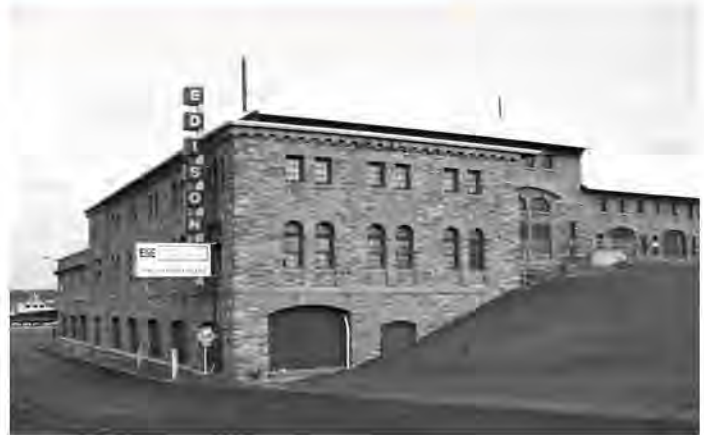
Facility Condition Index: +100% (Poor)

Utility System Infrastructure: The entire building interior needs to be remodeled. The mechanical and electrical systems are old and inefficient. The space configuration does not meet the current needs. The building does not meet ADA standards for plumbing or multi-floor access. The building is listed with the National Historic Civil Engineering Landmarks.

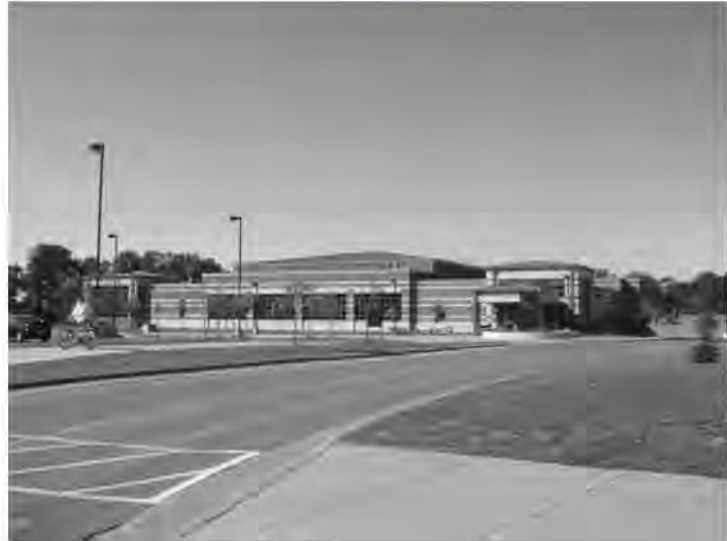
Facility Condition Index: 0.22% (Good)

This facility was opened in August of 2005 for classes and performances. The infrastructure is new and in excellent condition.

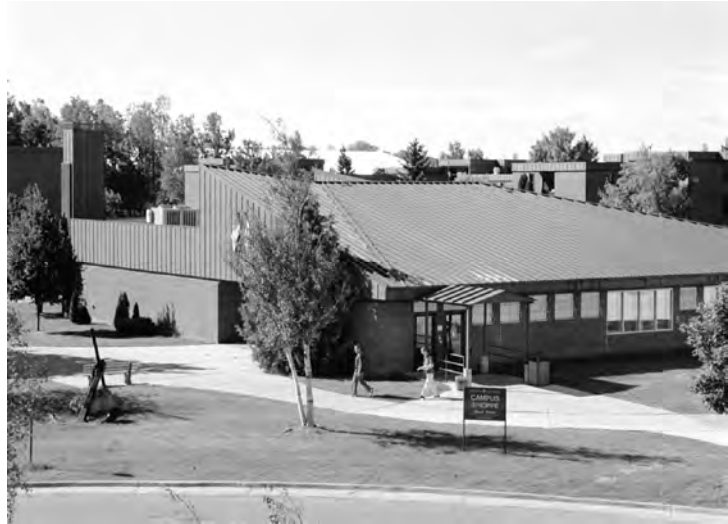
Facility Condition Index: 5% (Fair)

Building infrastructure is in fair condition with no major problems.

Year	Description	Estimate
2014 - 15	Replace fascia & soffit	\$15,000
2014 - 15	Dewater basement	\$5,000
2015 - 16	Install new fire alarm system	\$31,000
2016 - 17	Replace windows throughout building	\$40,000
2017 - 18	New electrical feed and panel	\$40,000
	TOTAL	<u>\$131,000</u>

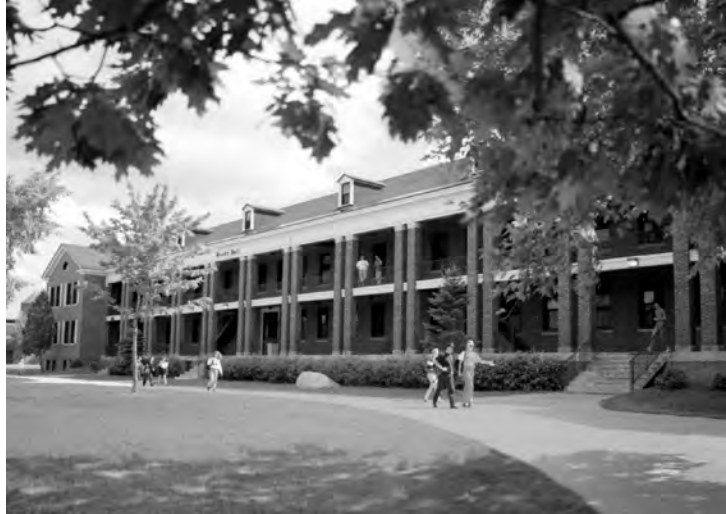
Facility Condition Index: 12% (Poor)

Building infrastructure is in good condition with no major problems. However, the building is circa 1939 and needs renovation work to be brought into the 21st century.

Year	Description	Estimate
2012 - 13	Repair water infiltration into basement	\$15,000
2012 - 13	Clean and seal porches	\$25,000
2013 - 14	Replace DHW recirc. lines, valves & pumps	\$20,000
2013 - 14	Replace SE exterior doors	\$6,000
2013 - 14	Electric re-heat elements for bathroom exhaust units	\$6,000
2013 - 14	Add card access entry system	\$25,000
2014 - 15	Renovate plumbing system	\$12,000
2014 - 15	Renovate bathrooms & showers	\$80,000
2014 - 15	Add exterior building drainage to south & east sides	\$20,000
2014 - 15	Replace flooring in basement hallways & areas	\$20,000
2014 - 15	Recore all locking hardware	\$10,000
2014 - 15	Clean, tuck-point and seal coat exterior	\$75,000
2015 - 16	Replace flat roof	\$160,000
2015 - 16	Re-shingle roof	\$50,000
2016 - 17	Add HVAC system to all floors	\$475,000
2016 - 17	Add fire suppression system	\$200,000
2017 - 18	ADA access to 1st floor	\$40,000
2017 - 18	Elevator	\$150,000

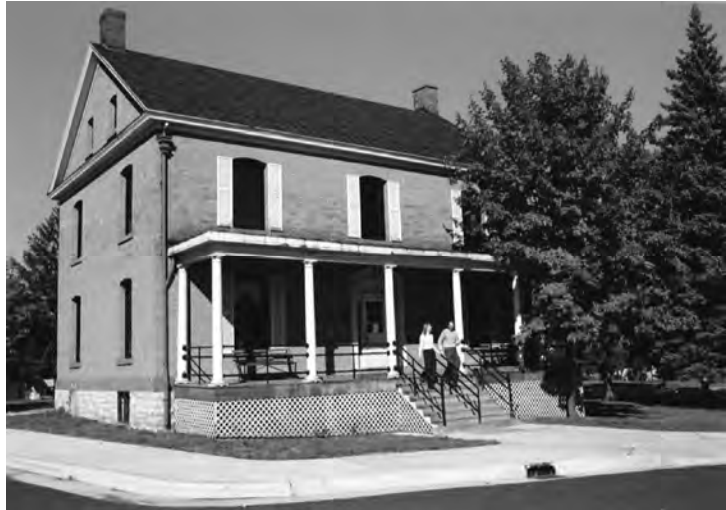
Facility Condition Index: 23% (Poor)

The building is in poor condition. This building is circa 1920 and in need of a major renovation to bring it into the 21st century.

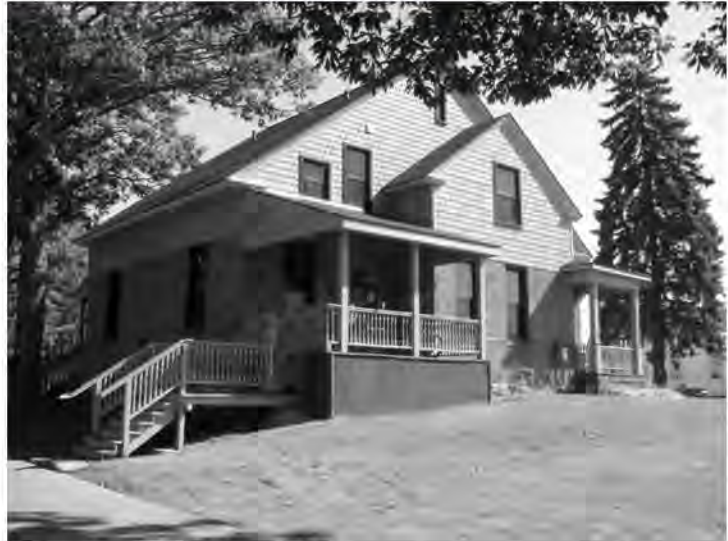
Mandated Facility Standards: N/A
Replacement Value: (2012 valuation) \$729,123
Facility Condition Index: 72% (Poor)

Building infrastructure is in poor condition, as the building interior needs to be remodeled to conform to all applicable codes.

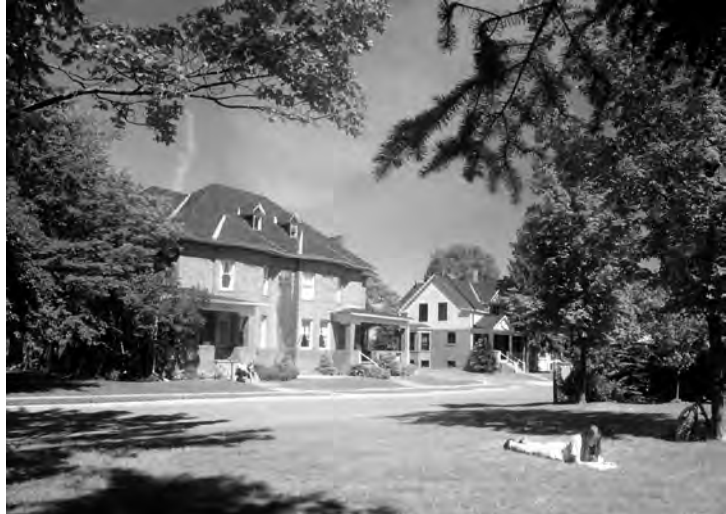
Facility Condition Index: 30% (Poor)

Building infrastructure is in poor condition as the building interior needs to be remodeled to conform to current codes. This building is circa 1901 and needs many renovations and improvements.

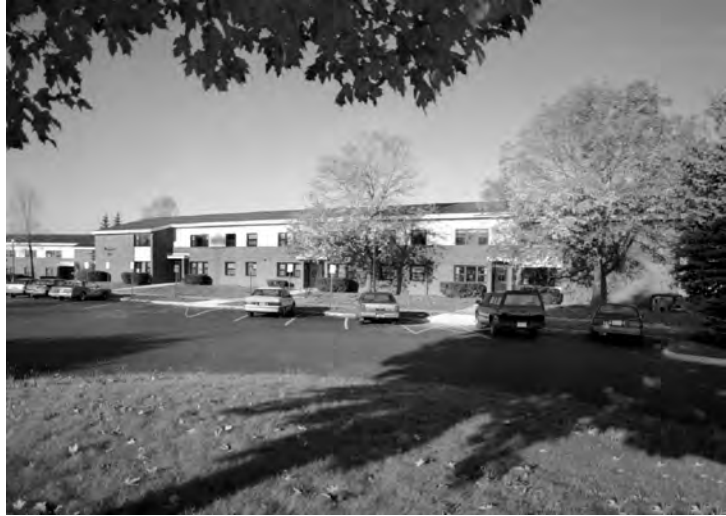
Facility Condition Index: Poor—Building Closed

Building infrastructure is in poor condition. The domestic water system needs to be replaced and building needs remodeling. This building is currently vacant.

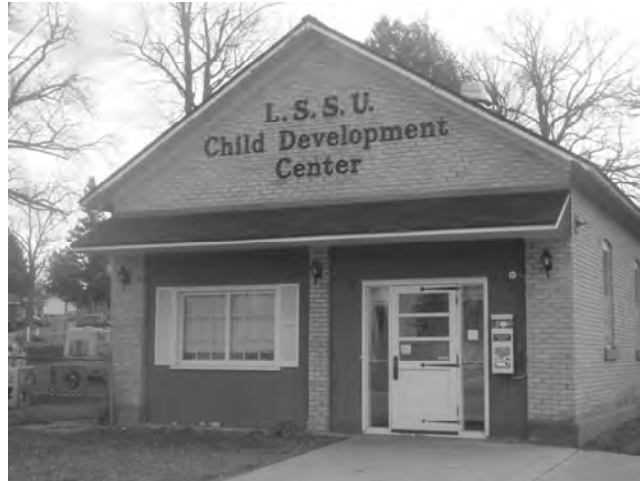
Facility Condition Index: 30% (Poor)

Building infrastructure is in poor condition.

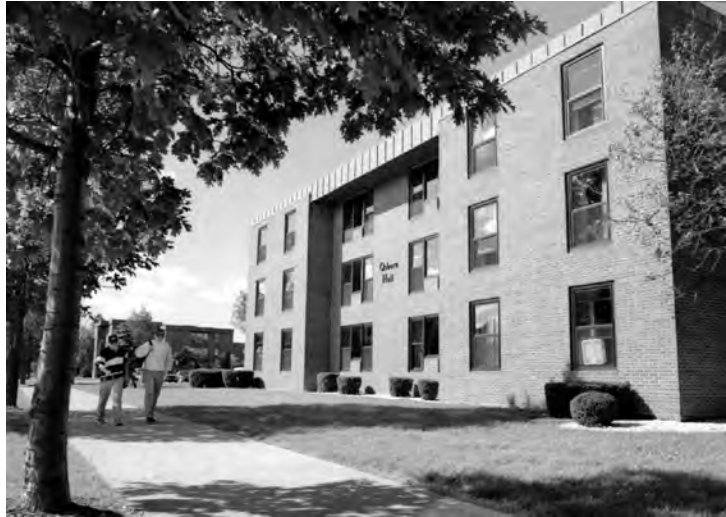
Facility Condition Index: 23% (Poor)

Building is structurally in fair condition but needs new heating and domestic water systems.

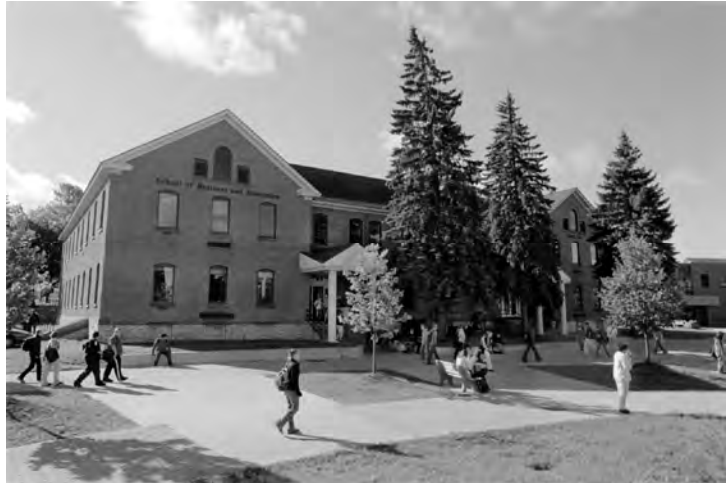
Facility Condition Index: +100% (Poor)

Building was vacated, August 2005. Planning has begun for complete renovation of South Hall.

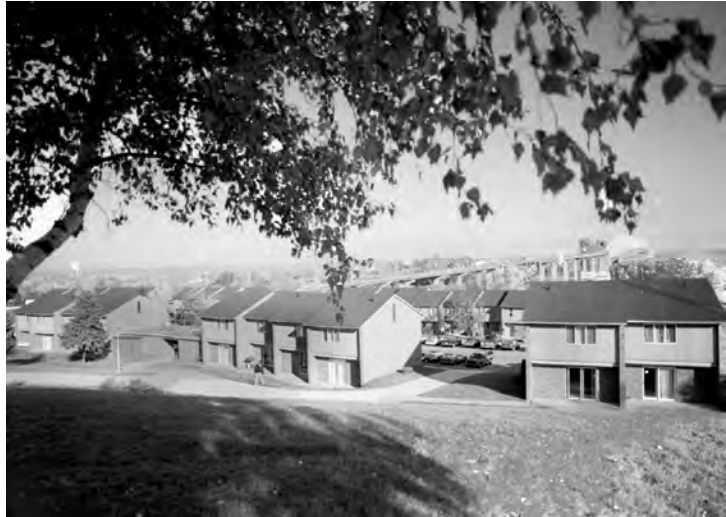
Facility Condition Index: 16% (Poor)

Building infrastructure is in generally fair condition although domestic water system needs replacement. Exterior needs to be painted. Townhouses need to be remodeled.
